# INSPECTION REPORT

[REDACTED]  
ST MARYS, GA

Inspection Date: [REDACTED]

RE: Report No. 1007  
[REDACTED]  
[REDACTED]

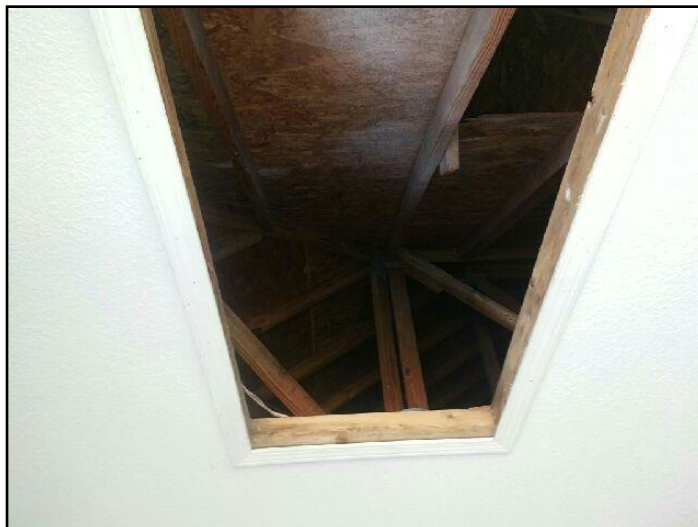
**1. Condition:** • no attic access pull down steps

**Location:** Garage

**Task:** Replace

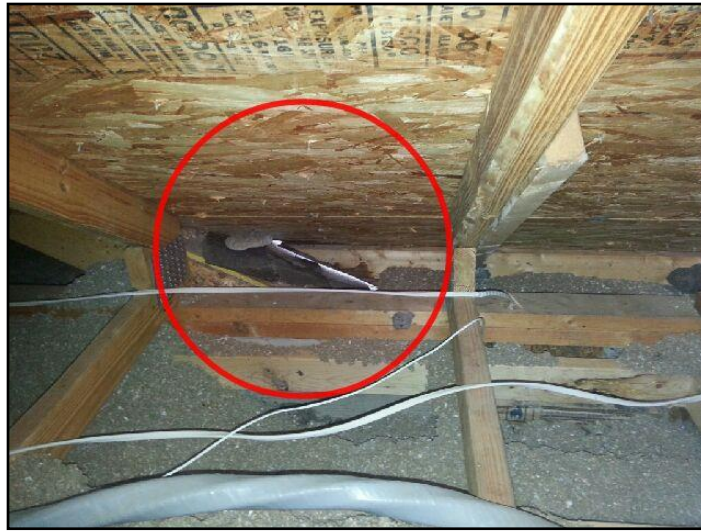
**2. Condition:** • Leak

both sides of faux dormer above the foyer are open to the attic space, ie there is a gap between the roof and wall where water can get in. There is visible water staining on the framing in this area. This could be where the water damage to the wood floor inside came from.

Leak

**Task:** Repair

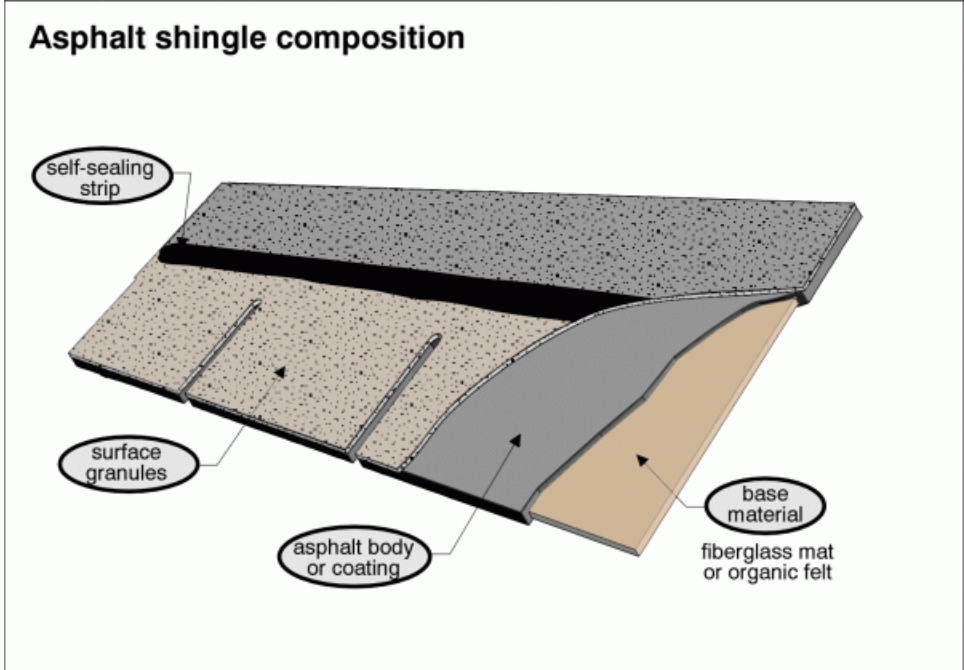
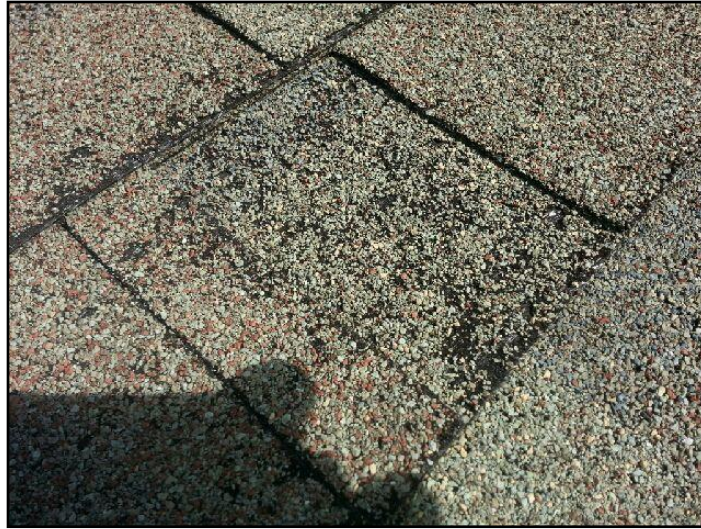
**3. Condition:** • Granule loss  
**Location:** Addition  
**Task:** Monitor

*Granule loss*

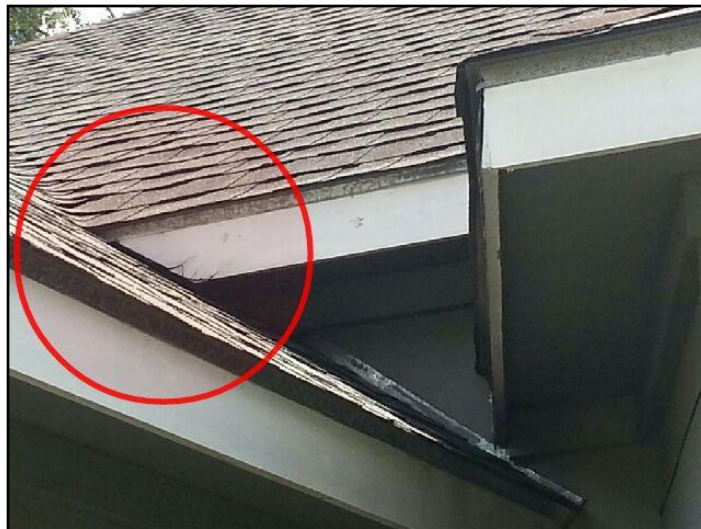
**4. Condition:** • Damage  
fascia water damaged  
**Location:** Front Dining Room  
**Task:** Further evaluation  
**Time:** Immediate

*Damage*

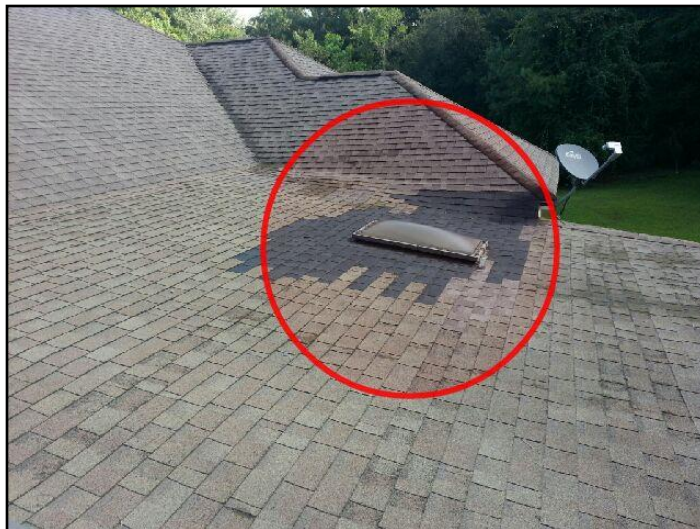
**5. Condition:** • Patched  
**Location:** Addition  
**Task:** Monitor

*Patched*

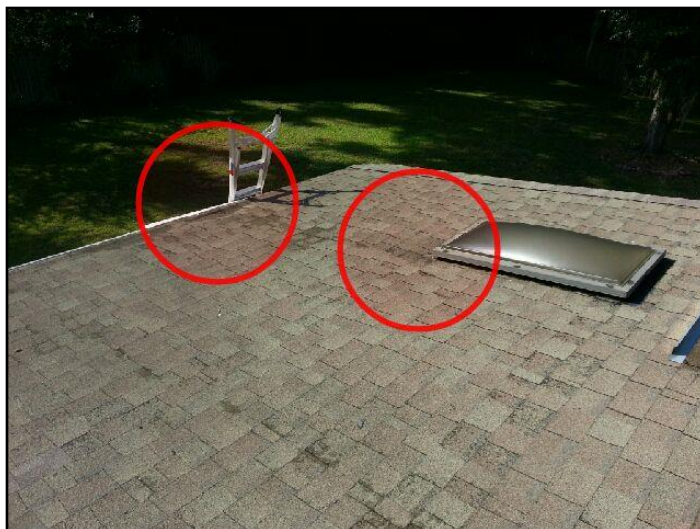
**6. Condition:** • Vulnerable areas  
soft sheathing in red circle locations. Sheathing will need to be replaced in those areas.

*Vulnerable areas*

**Task:** Repair or replace

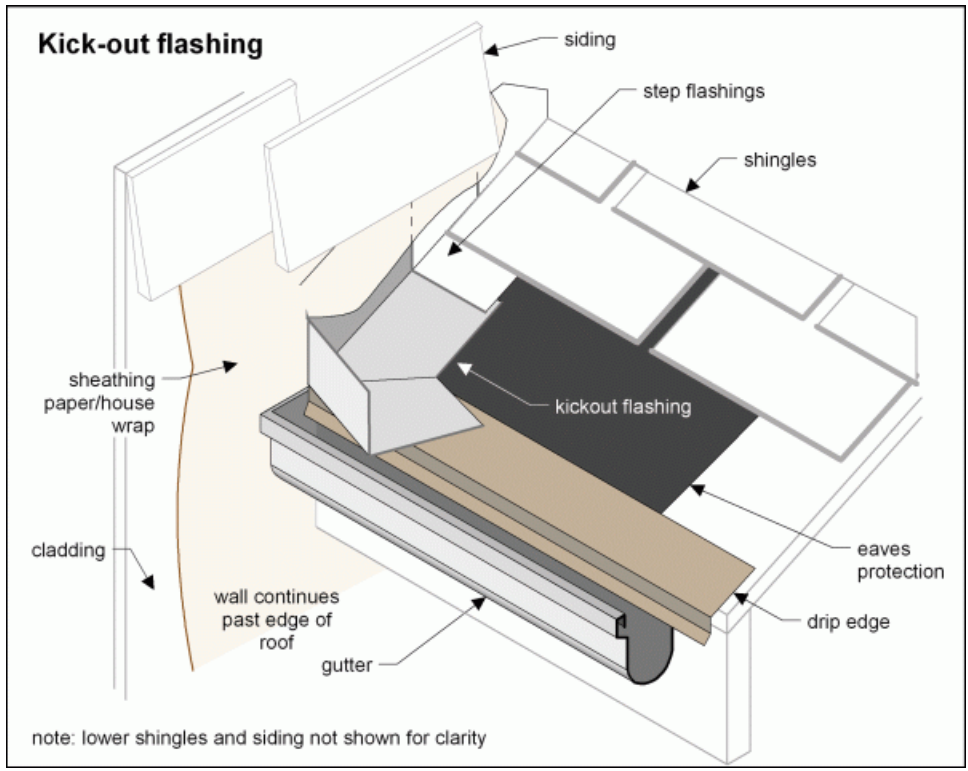
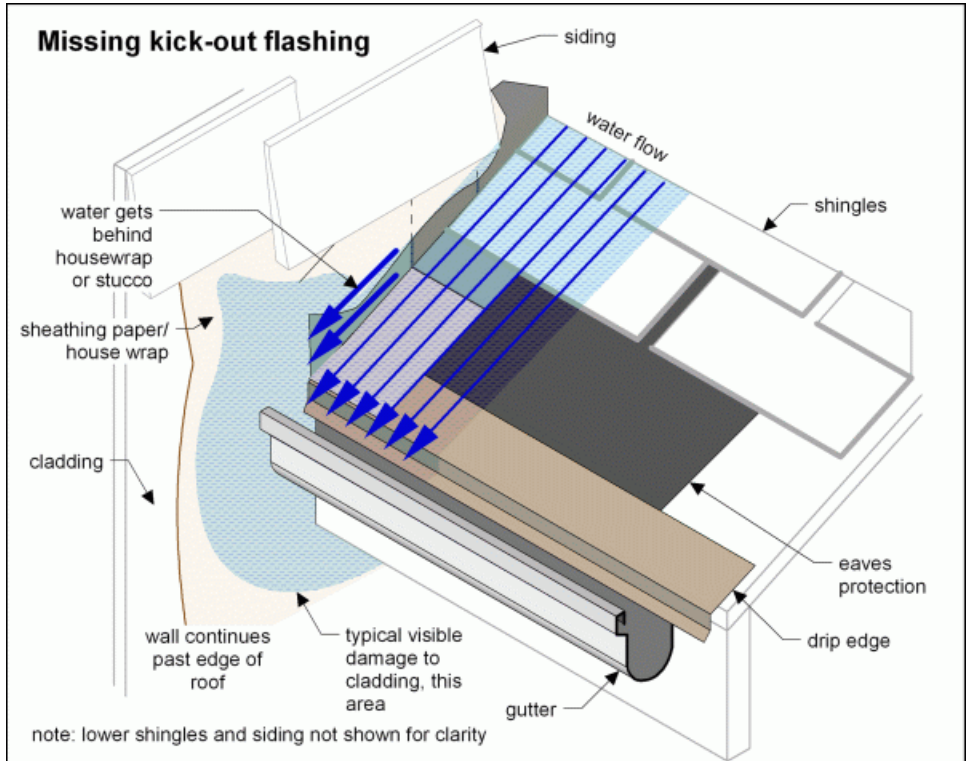
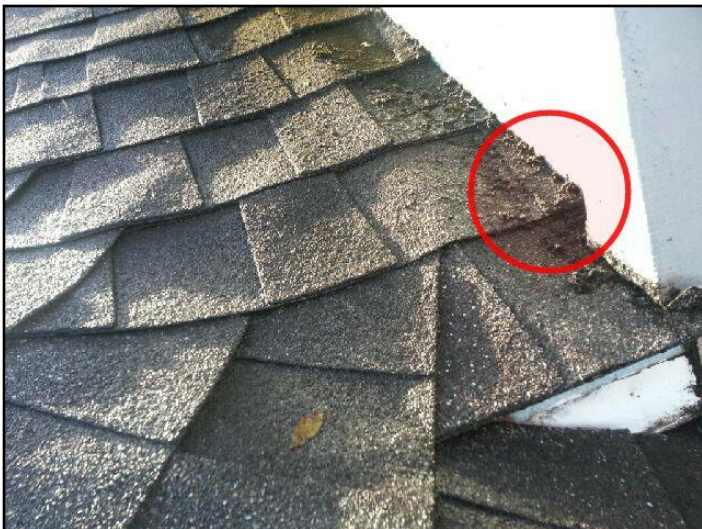
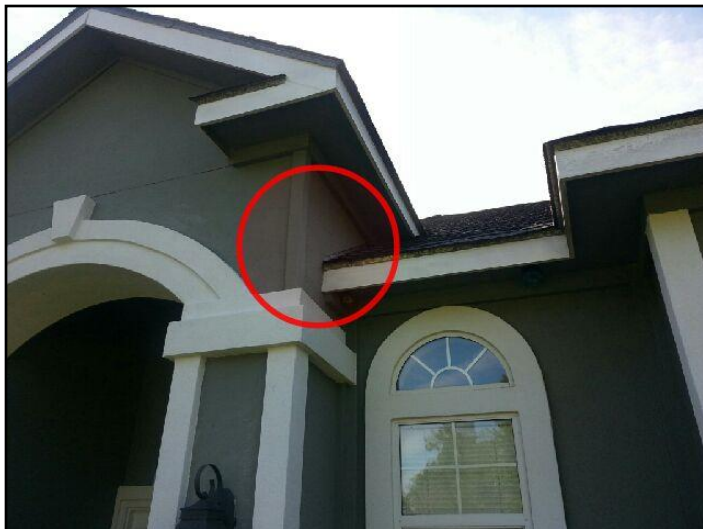
**7. Condition:** • No kickout flashing  
it appears that water is hitting the corner trim and is causing it to rot. Recommend kick out flashing to keep water away from trim or at least cut the trim back so it is off the roof.

No kickout flashing

**Task:** Repair

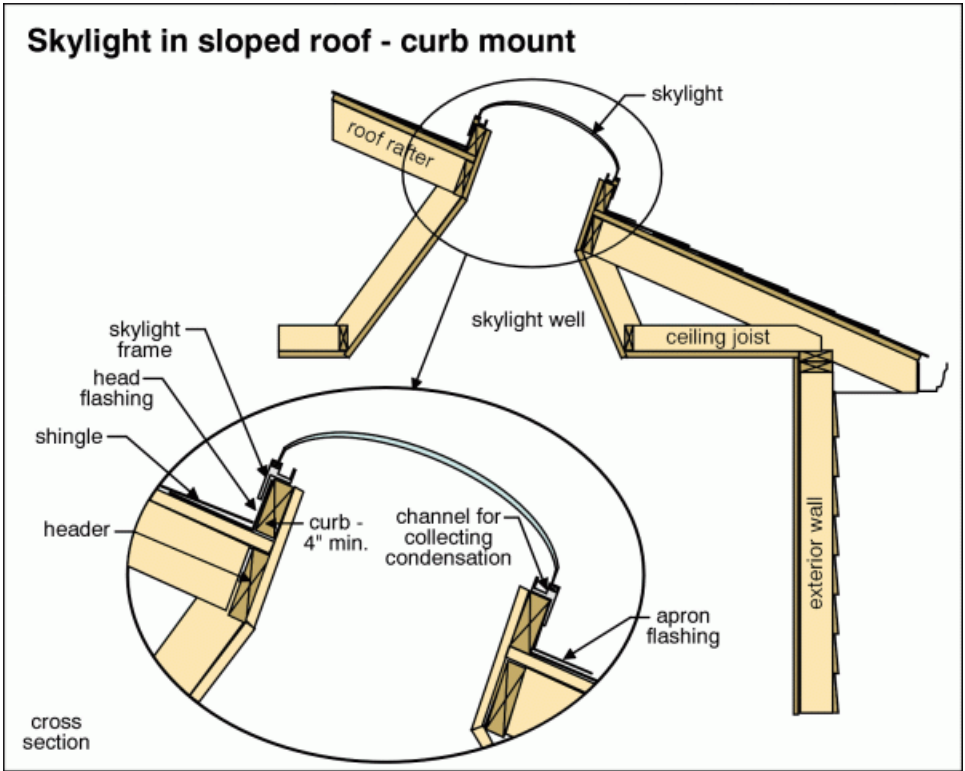
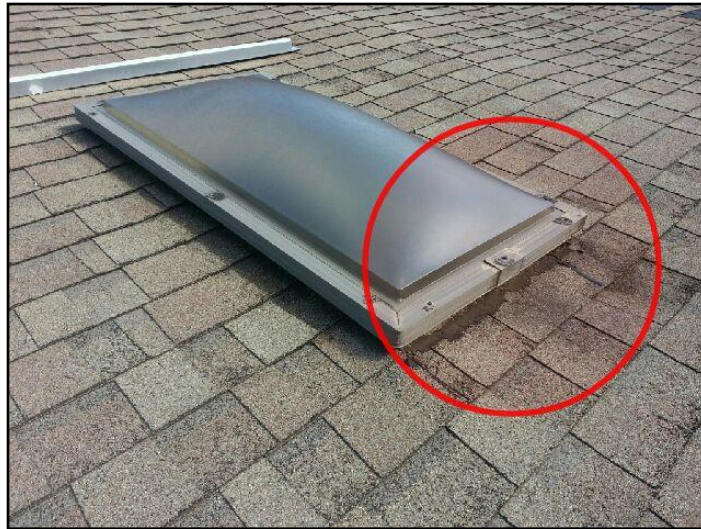
**8. Condition:** • Wrong, incomplete flashings  
No flashing visible on the lower slope. Roof sheathing is soft in the red circle area.  
**Location:** Rear Addition  
**Task:** Repair  
**Time:** Immediate  
**Cost:** Depends on work needed

*Wrong, incomplete flashings*

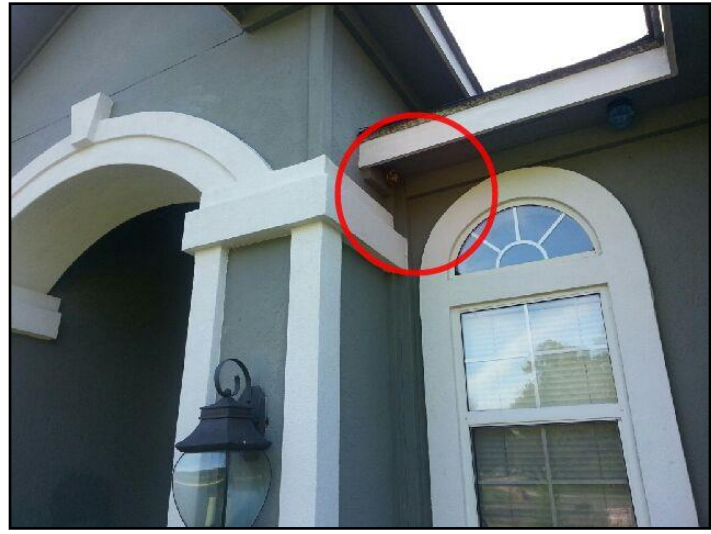
**9. Condition:** • wasp nest on right side of entrance. And in the attic space near the dormer areas where water is getting in.

**Task:** Clean

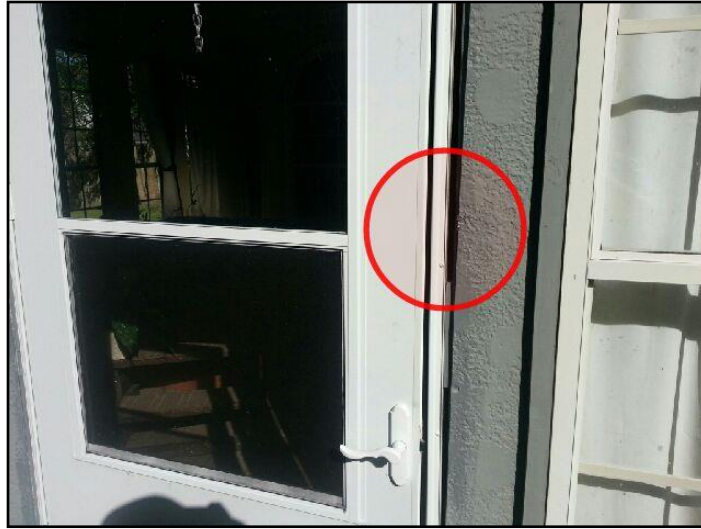
**10. Condition:** • Missing

There is no door trim around this back door to the hot tub / addition area.

*Missing*

**Task:** Replace

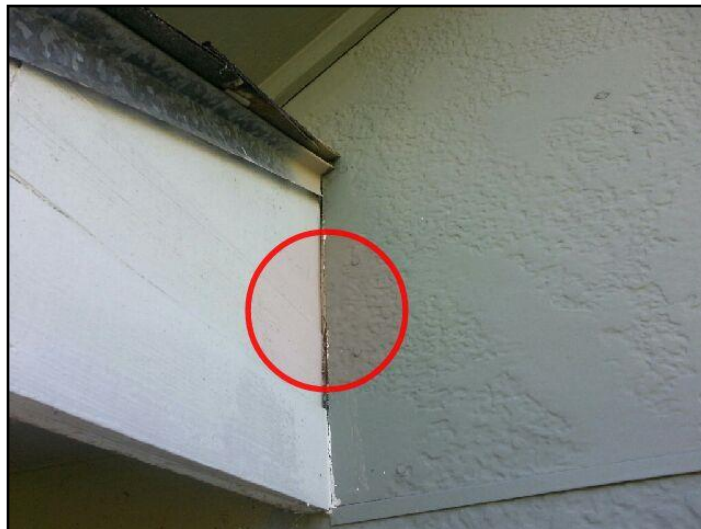
**11. Condition:** • Caulking missing or ineffective

*Caulking missing or ineffective*

**Task:** Repair

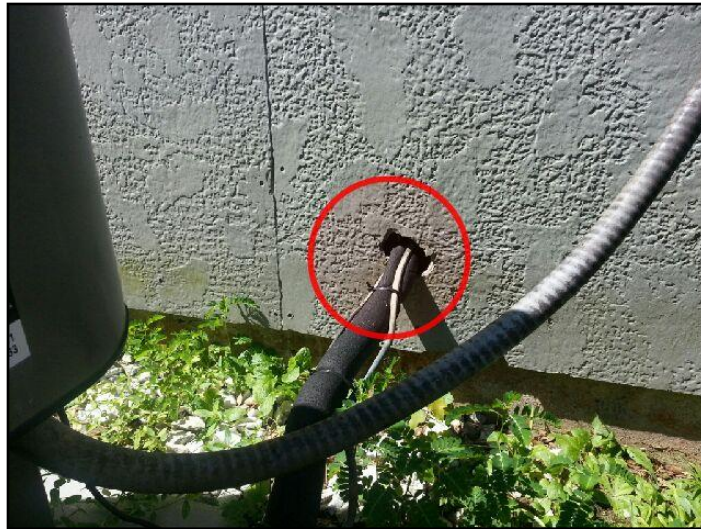
**12. Condition:** • Caulking missing or ineffective

*Caulking missing or ineffective*

**Task:** Repair

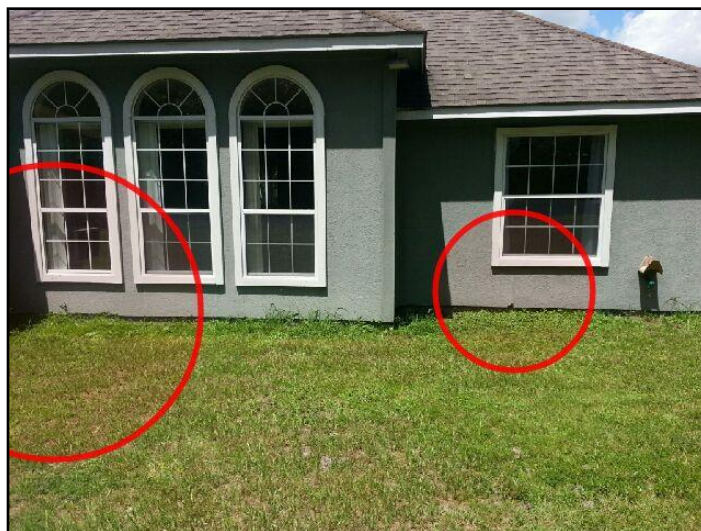
**13. Condition:** • Mechanical damage

Chips and cracks at lower edges of hardboard siding in various locations around the house. Not major, but should be monitored and caulked if necessary

*Mechanical damage*

**Task:** Repair

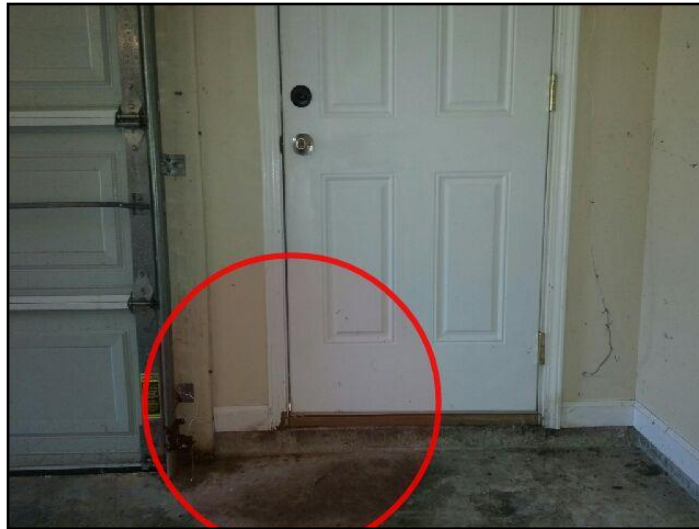
**14. Condition:** • Loose or poor fit

air gap and evidence of water intrusion rotting wood trim

*Loose or poor fit*

**Task:** Repair

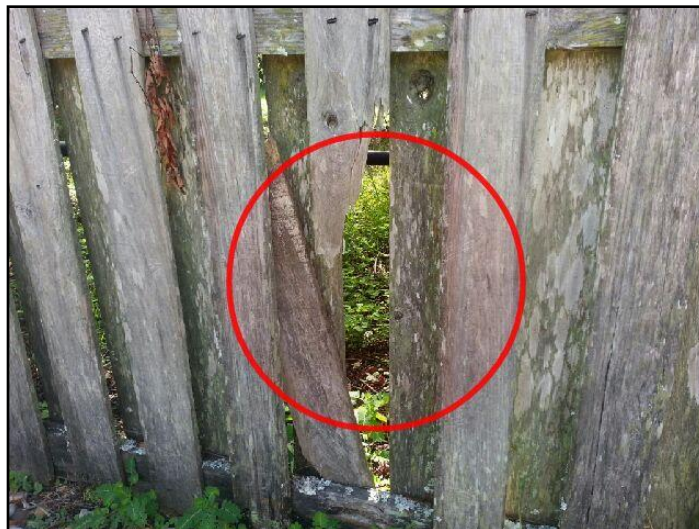
**15. Condition:** • Deteriorated

*Deteriorated*

**Task:** Repair

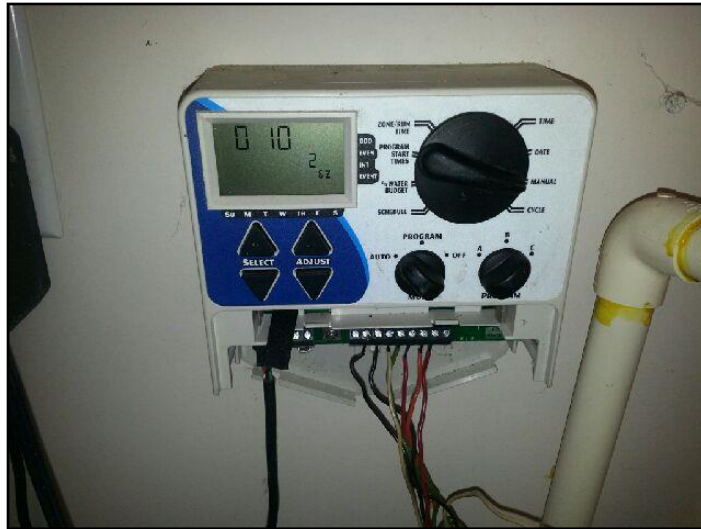
**16. Condition:** • Controller defective

could just be a lack of understanding but I could not get the sprinkler system to activate on any setting. Recommend for the evaluation by professional

*Controller defective*

**Task:** Further evaluation

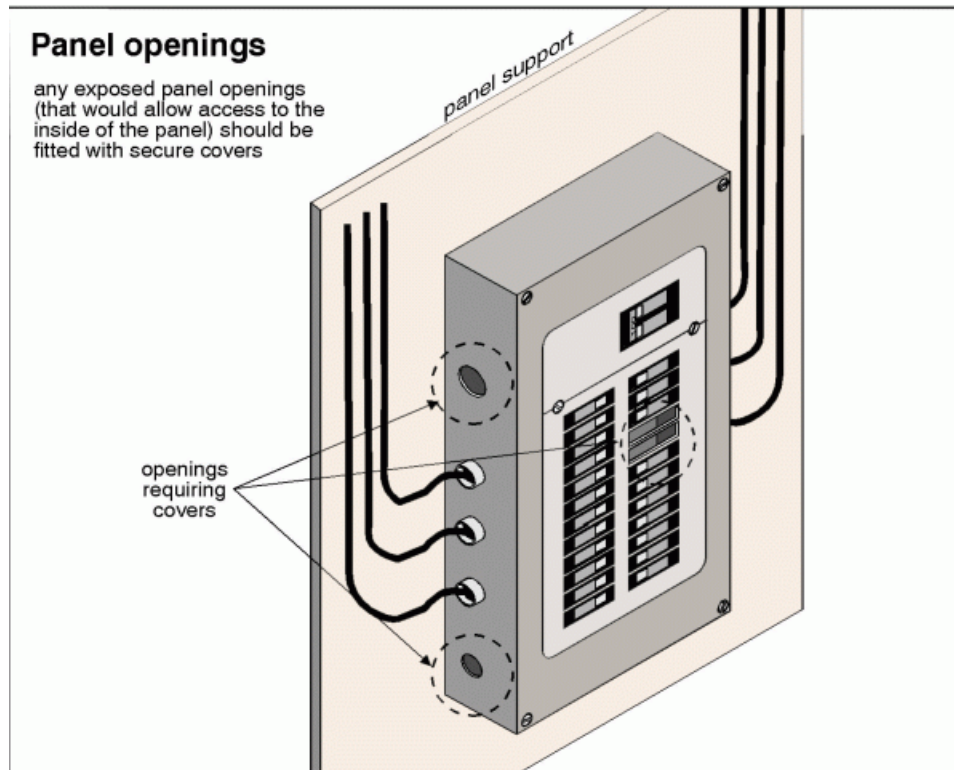
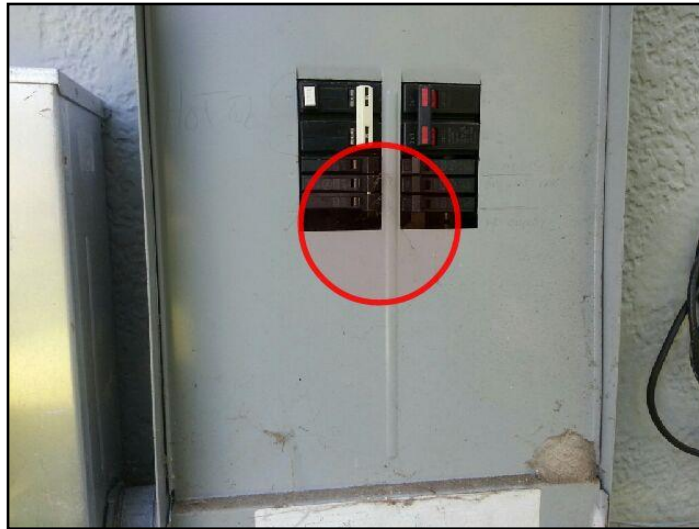
**17. Condition:** • Openings in panel

*Openings in panel*

**Task:** Correct

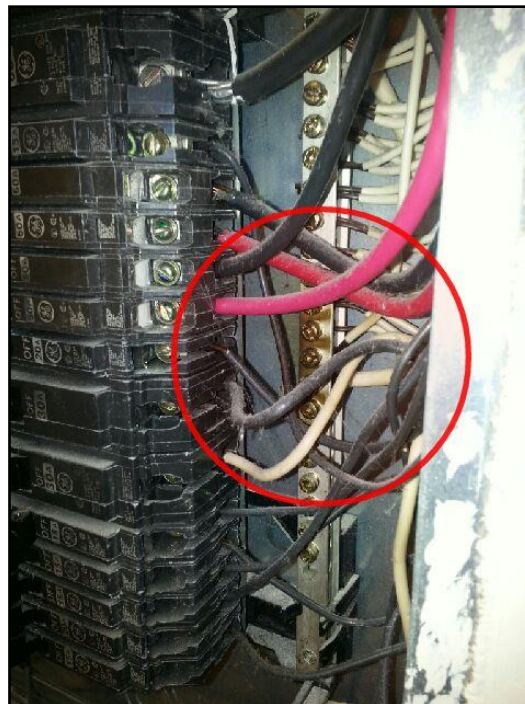
**19. Condition:** • Overheating  
evidence of previous overheating or smoke

*Overheating*

**Task:** Further evaluation

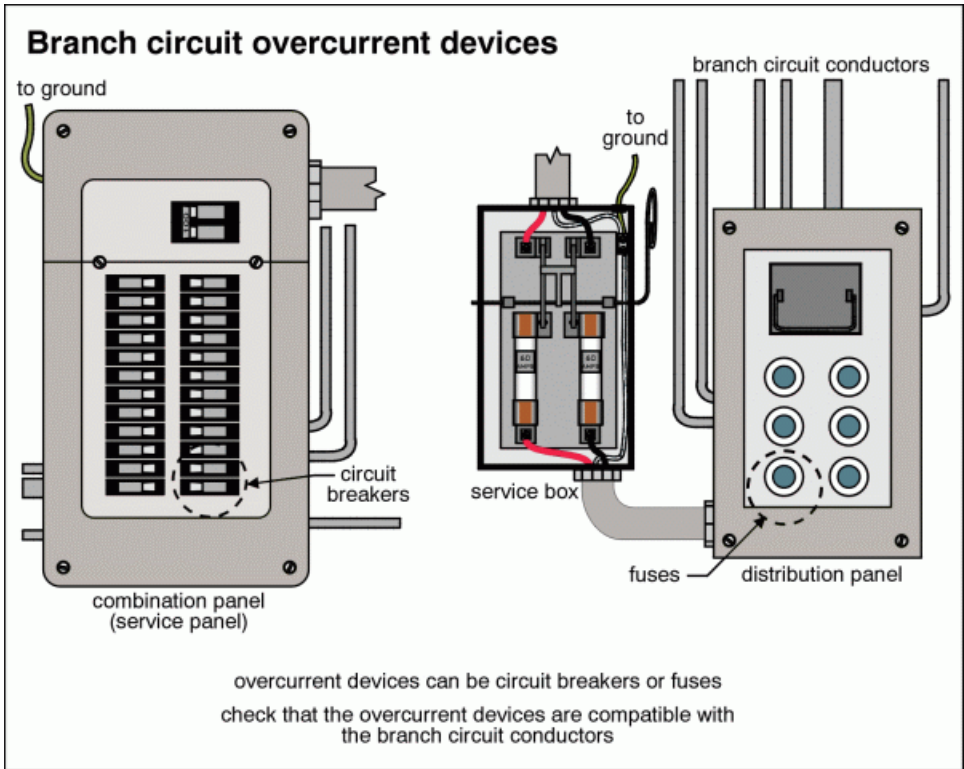
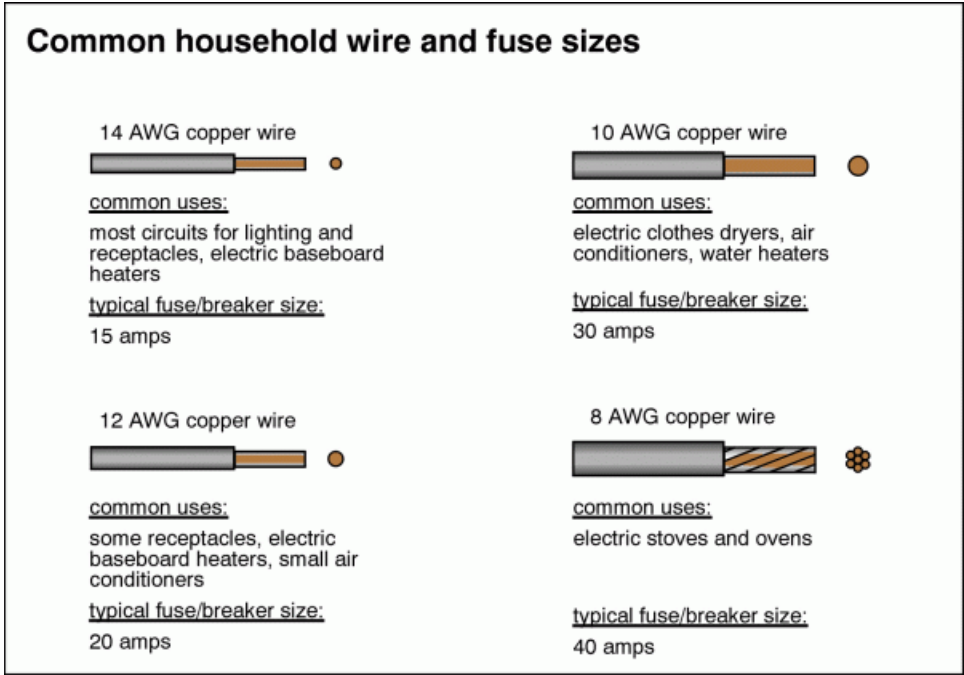
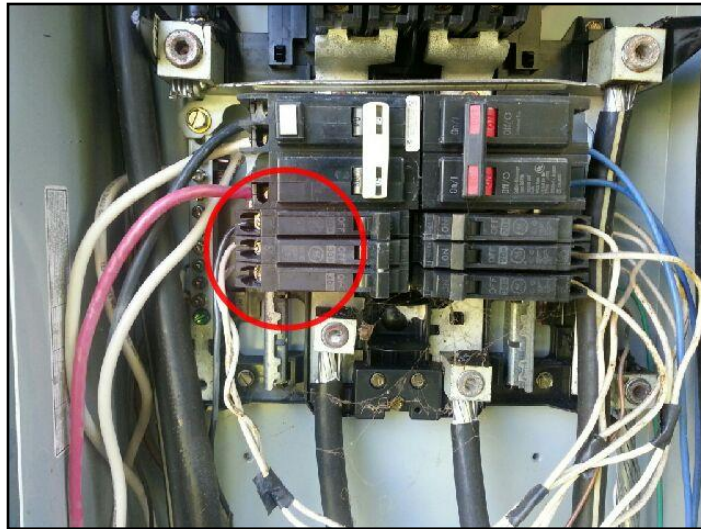
**20. Condition:** • Fuses or breakers too big

30 amp breakers on 20 amp wire. Replace breakers with 20 amp breakers to match the wire. This applies to the three

lower left breakers on the exterior panel

*Fuses or breakers too big*

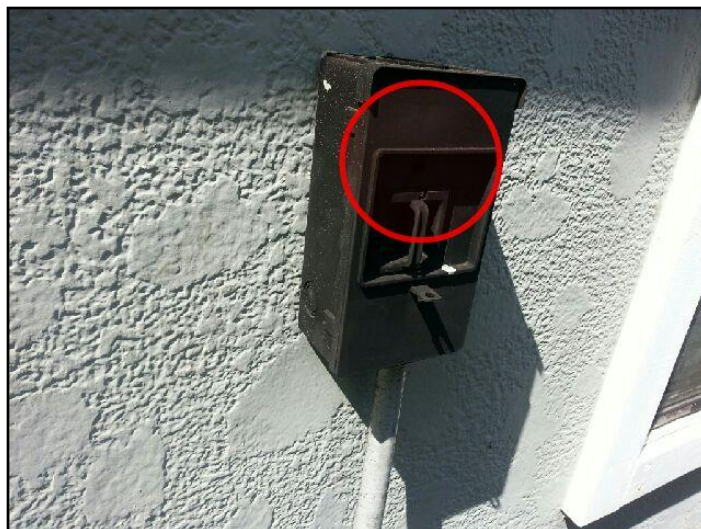
**21. Condition:** • Cover loose or missing

*Cover loose or missing*

**Task:** Replace

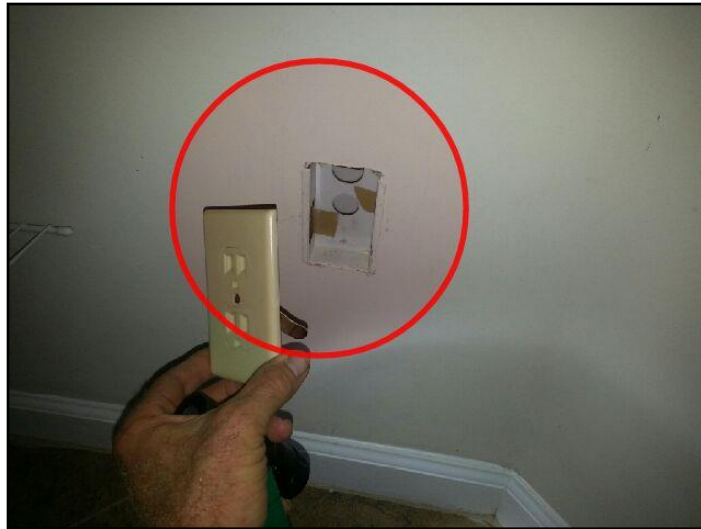
**22. Condition:** • Inoperative

*Inoperative*

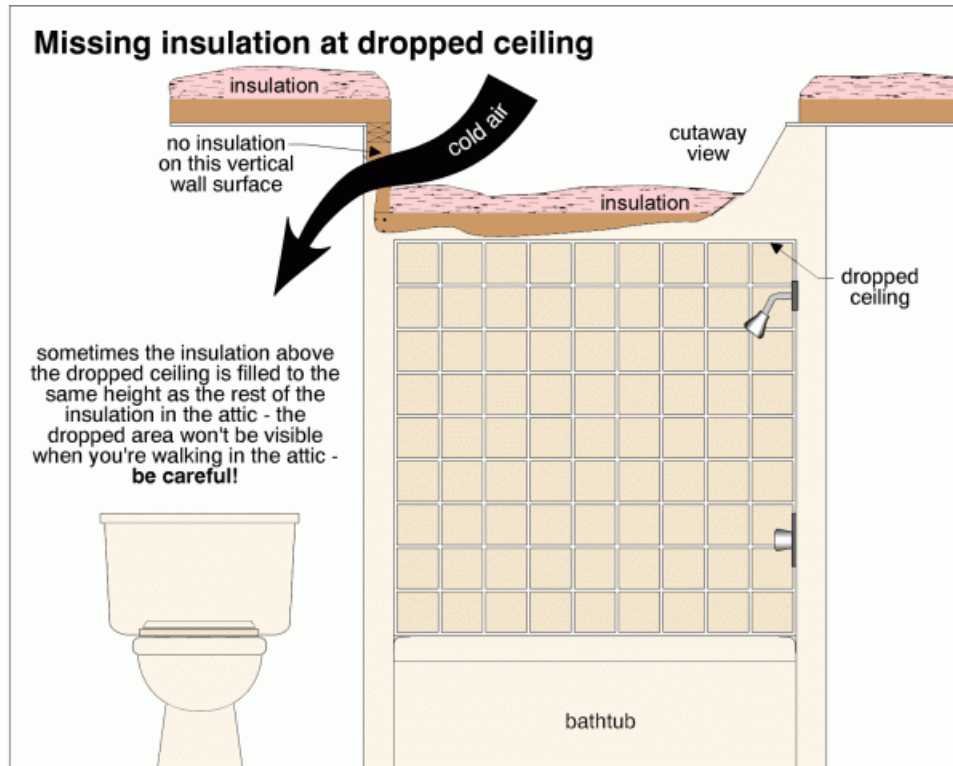
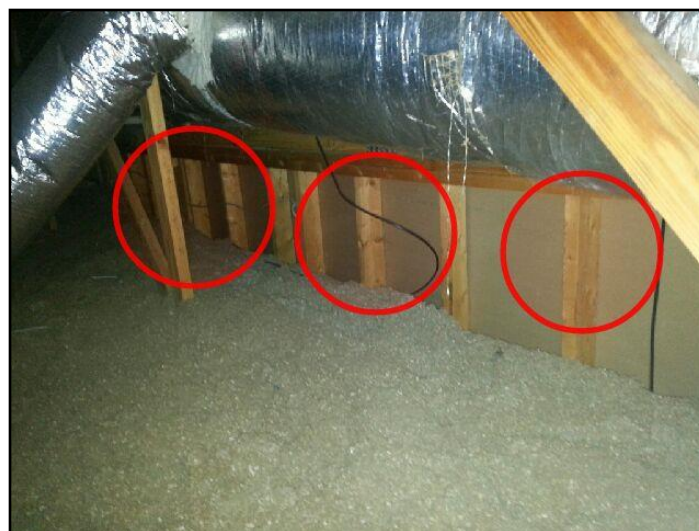
**23. Condition:** • Missing at dropped ceilings

*Missing at dropped ceilings*

**Task:** Replace

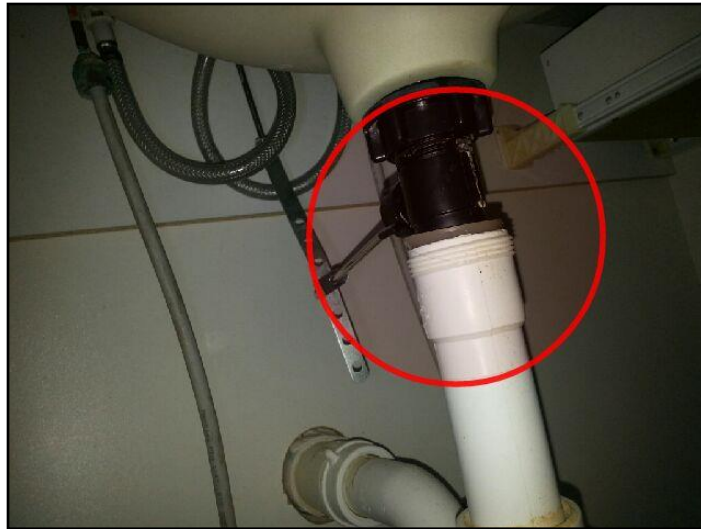
**24. Condition:** • missing top cap at drain pipe. Could leak in future.

**Task:** Replace

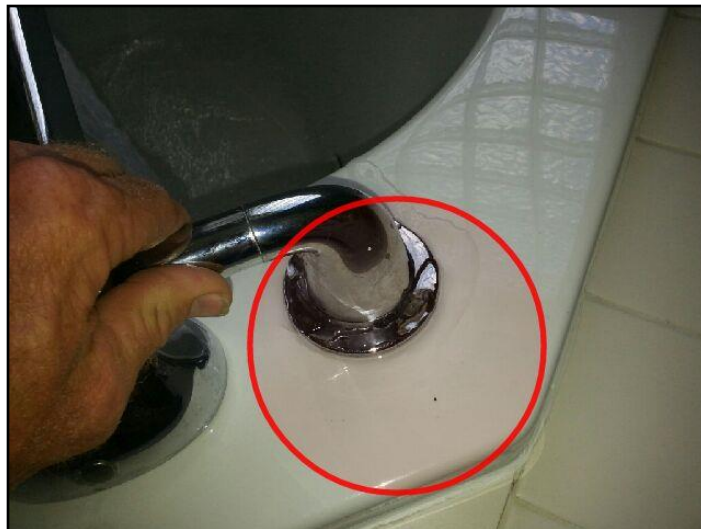
**26. Condition:** • Drip, leak  
Master garden tub faucet leaking at base.  
**Location:** Master Bathroom  
**Task:** Repair

*Drip, leak*

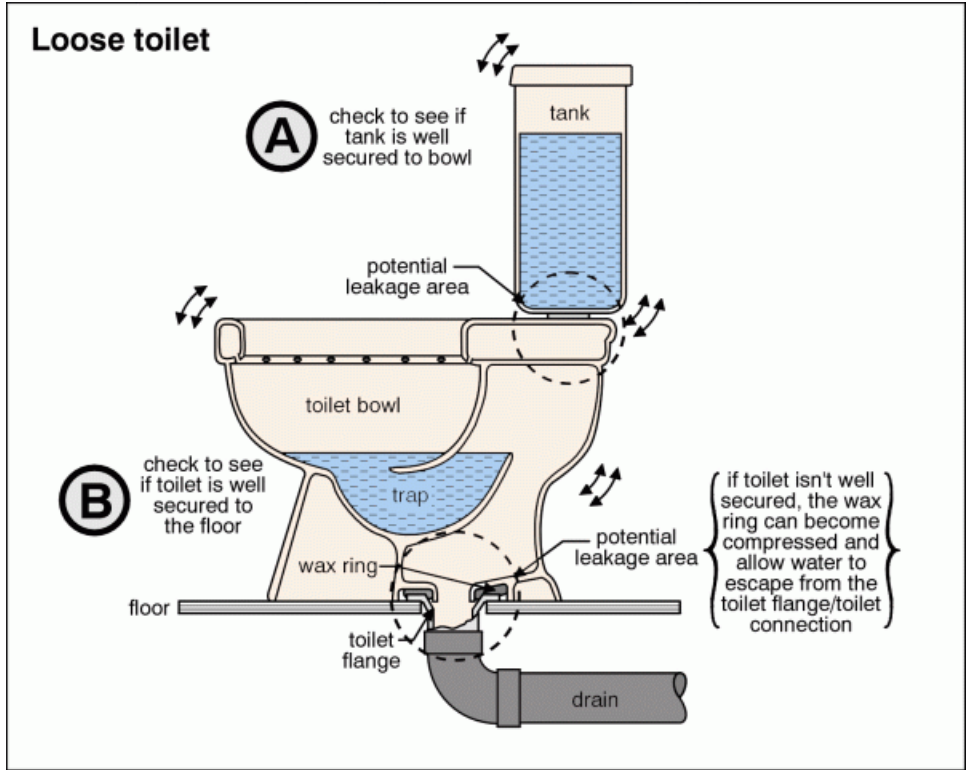
**27. Condition:** • Loose  
**Location:** Hallway Bathroom

**Task:** Repair  
**Cost:** Minor

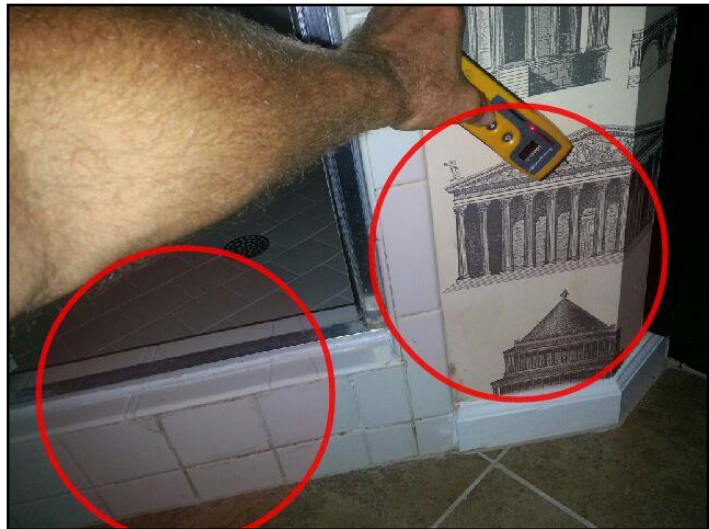
**28. Condition:** • Leak

The step below the door and the wall up 2 foot to the right of the door have elevated moisture levels. This could be the door leaking or the shower pan leaking. The wall is wet too so that needs to be taken care of.

Leak

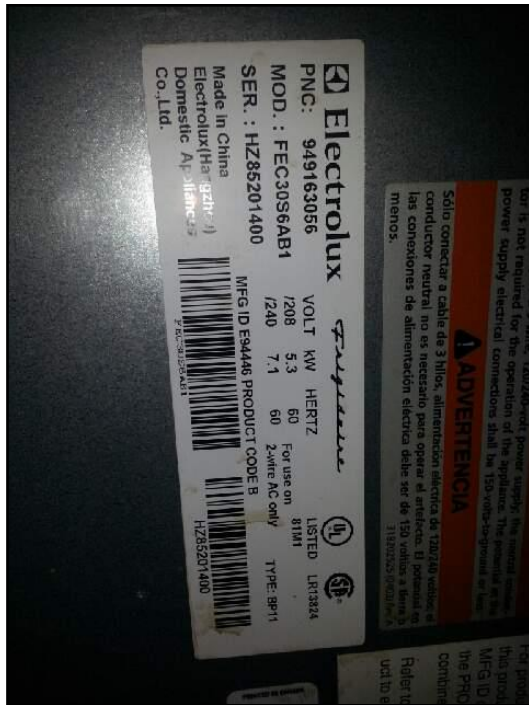
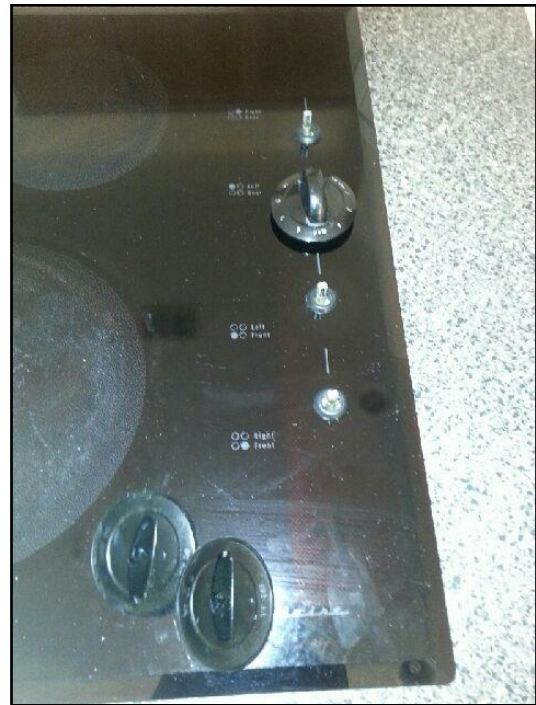
- Frigidaire
- 3 knobs broken

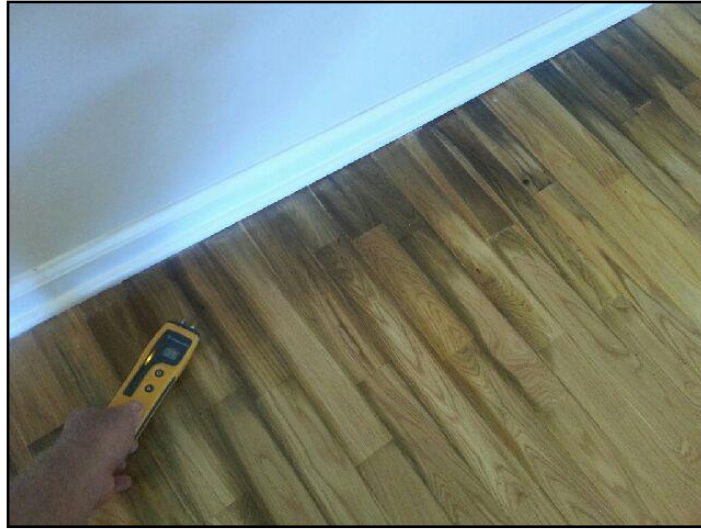
**29. Condition:** • Stained  
elevated moisture

Stained

**Task:** Repair

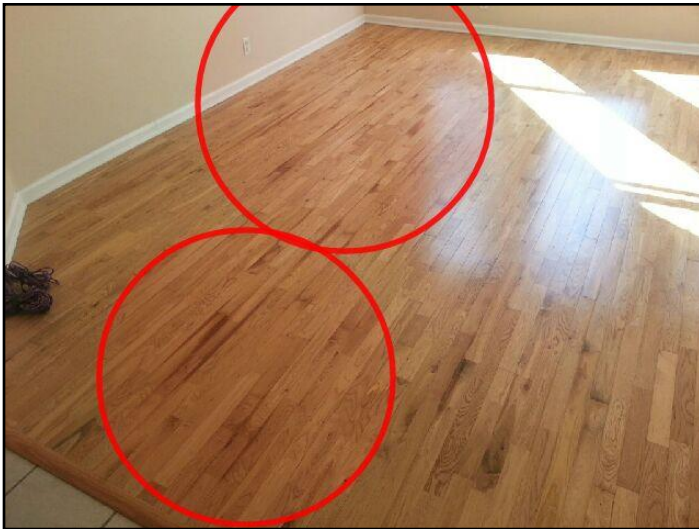
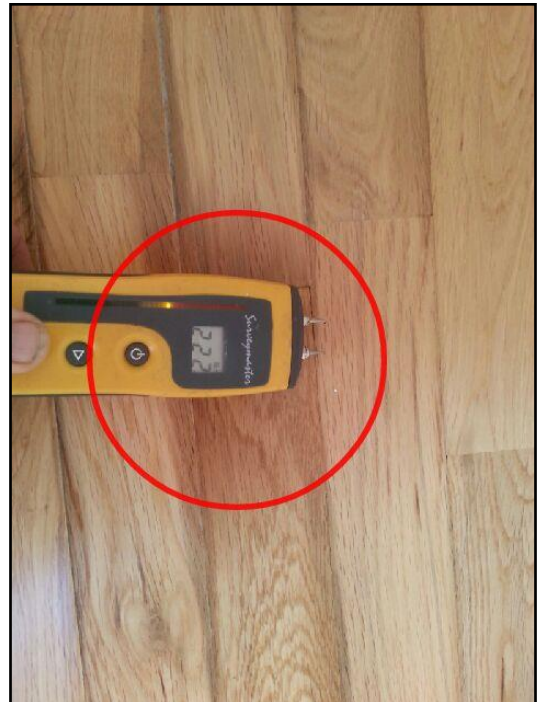
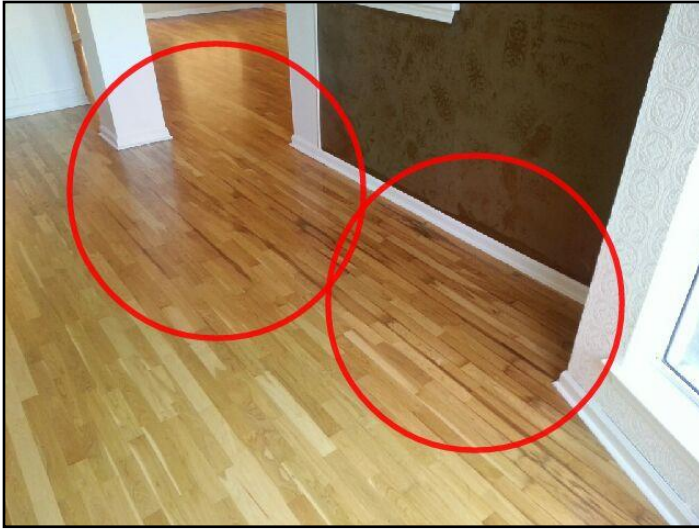
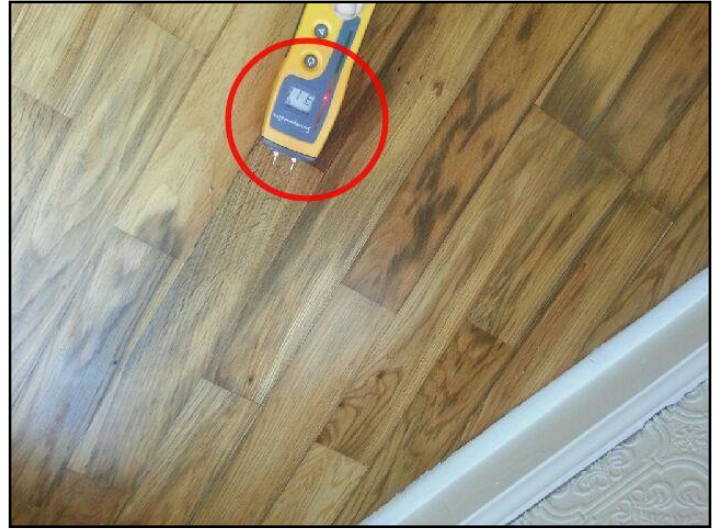
**30. Condition:** • Stained

evidence of moisture under the wood floor in dining room, sun room, living room and foyer.

Stained

*Stained*

**Task:** Replace Damaged Flooring. Repair source of moisture.

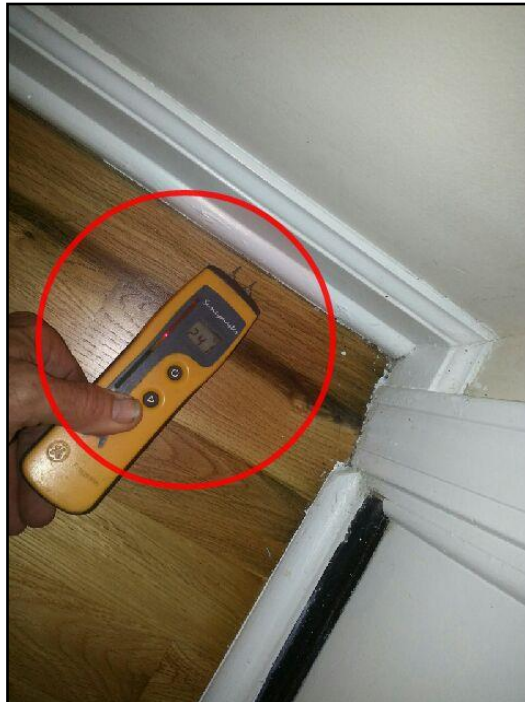
**31. Condition:** • Stained

Stained, and slightly elevated moisture level.

*Stained*

**Task:** Replace

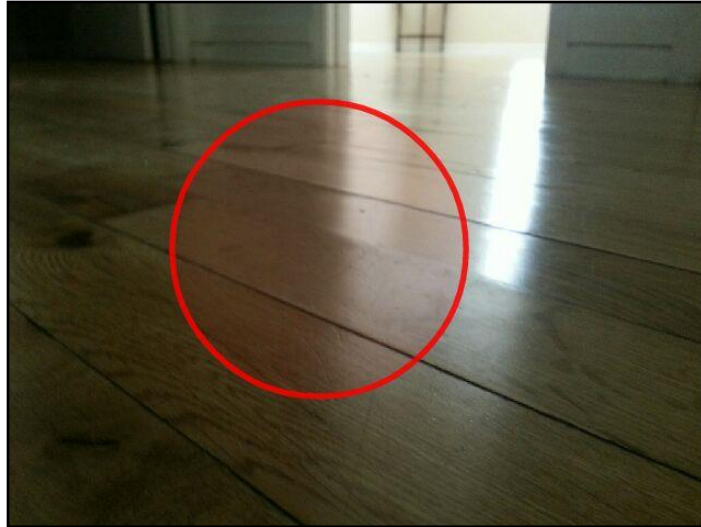
**32. Condition:** • Warped

the unevenness could just be bad installation but the cupping is the same as you see with water damage. However there is no staining and moisture levels are normal, so the probability is poor installation. A flooring specialist should be able to tell if this floor can be refinished or not.

*Warped*

**Task:** Repair or replace

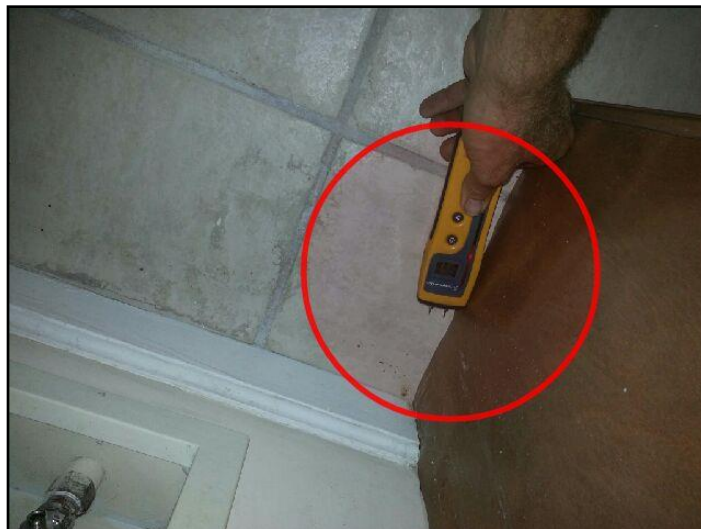
**33. Condition:** • Stains on tiles

slightly elevated moisture level and evidence of previous water damage to fridge wood side enclosure

*Stains on tiles*

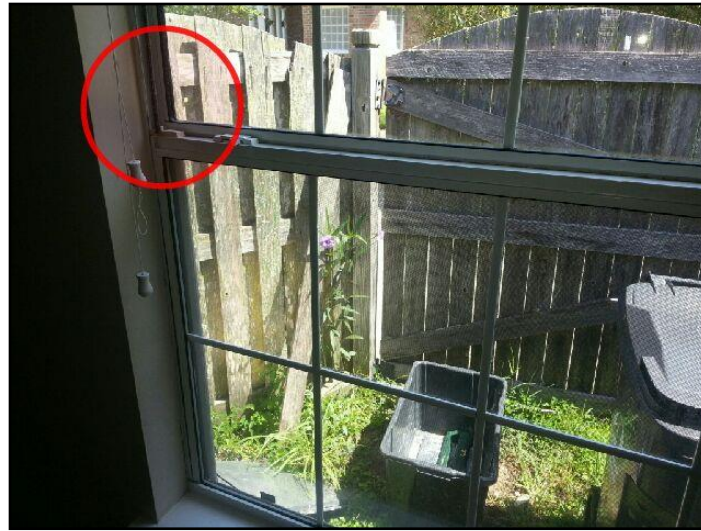
**34. Condition:** • Inoperable

window wont stay open due to broken support spring

*Inoperable*

**Task:** Repair

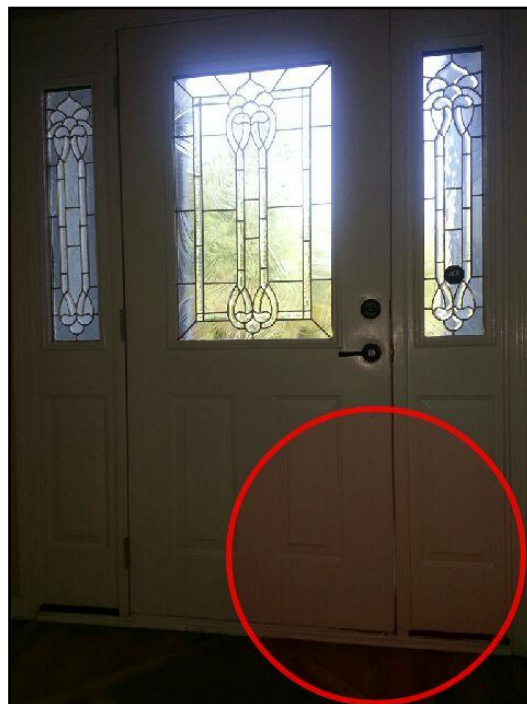
**35. Condition:** • Racked/out-of-square appears to be the hinges not the frame

*Racked/out-of-square*

**Task:** Repair

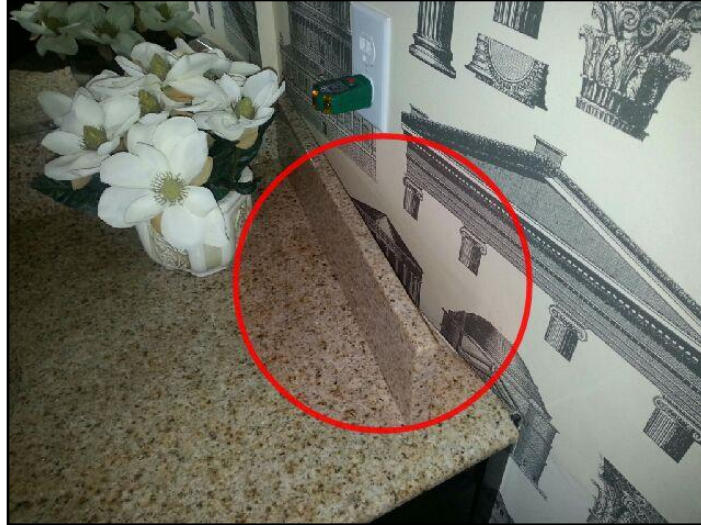
**36. Condition:** • Loose or missing pieces  
Backsplashes not attached securely or caulked.

*Loose or missing pieces*

**Task:** Repair

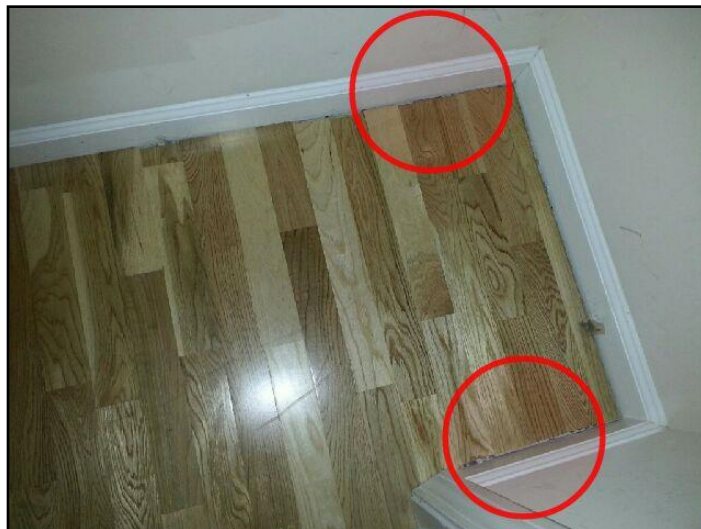
**37. Condition:** • Missing  
missing shoe molding trim in closet

*Missing*
