# INSPECTION REPORT

[REDACTED]  
ST MARYS, GA

Inspection Date: [REDACTED]

RE: Report No. 1007  
[REDACTED]  
[REDACTED]

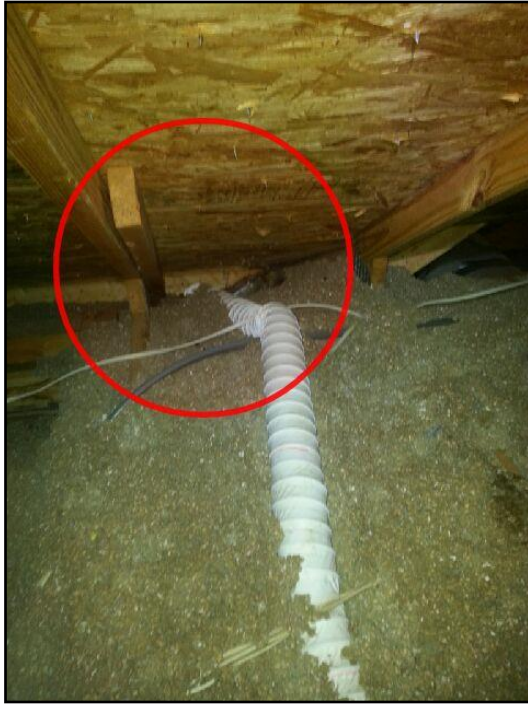
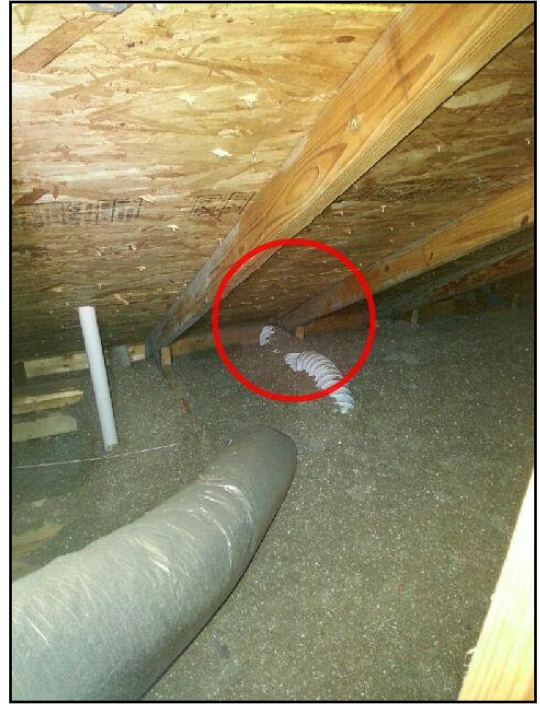
**38. Condition:** • Not vented to exterior

Not vented to exterior

**Task:** Repair

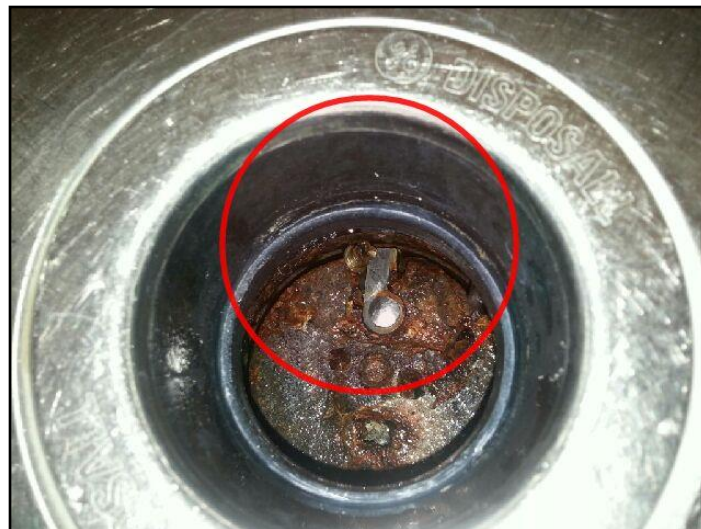
**39. Condition:** • Inoperative grinder broken  
**Task:** Replace  
**Cost:** Minor

Inoperative
